GREEN LANE RESERVOIR DAM

NDI - PA 00618
PA DER 46-250

PHASE I INSPECTION REPORT
NATIONAL DAM INSPECTION PROGRAM

OVERVIEW
GREEN LANE RESERVOIR DAM, MONTGOMERY COUNTY, PENNSYLVANIA

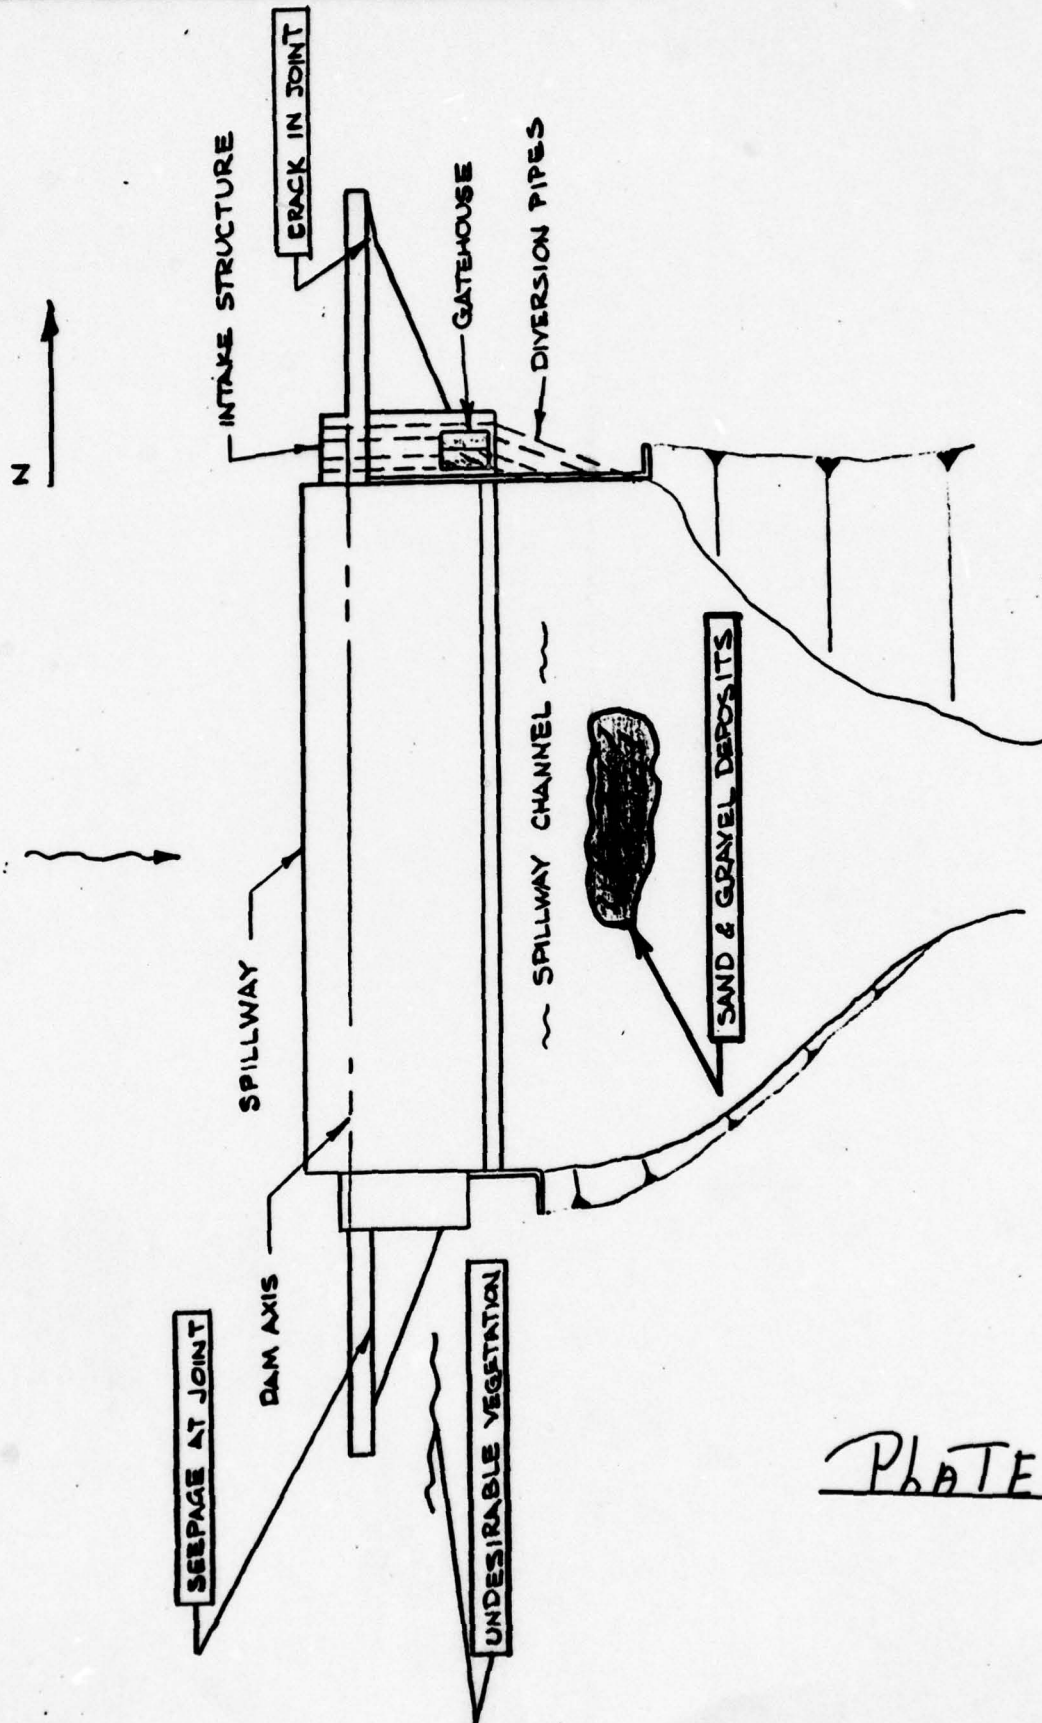
PLATE 9

b. Dam. Spalling of the concrete surface was noted in a few isolated areas on the downstream face of the north non-overflow section of the dam. A crack in the vertical joint nearest to the north abutment was also evident. However, steel was not exposed at any of these locations and no indications of movement could be detected at the joint.

Several calcification deposits were apparent on the downstream face of both the north and south non-overflow sections of the dam. Seepage, in the form of surface moisture, was noted along a horizontal joint in the south non-overflow section of the dam. The quantity of seepage could not be determined, but was minimal.
